Project: EXTERIOR FACADE RESTORATION  
**Milwaukee Public Museum**  
800 West Wells Street  
Milwaukee, WI 53233-1478

Subject: **Milwaukee Public Museum Marble Façade**  
**By**  
**GRAEF, Inc.**  
December, 2010

# **MILWAUKEE PUBLIC MUSEUM MARBLE FAÇADE**

**Project No. 2010-0161**

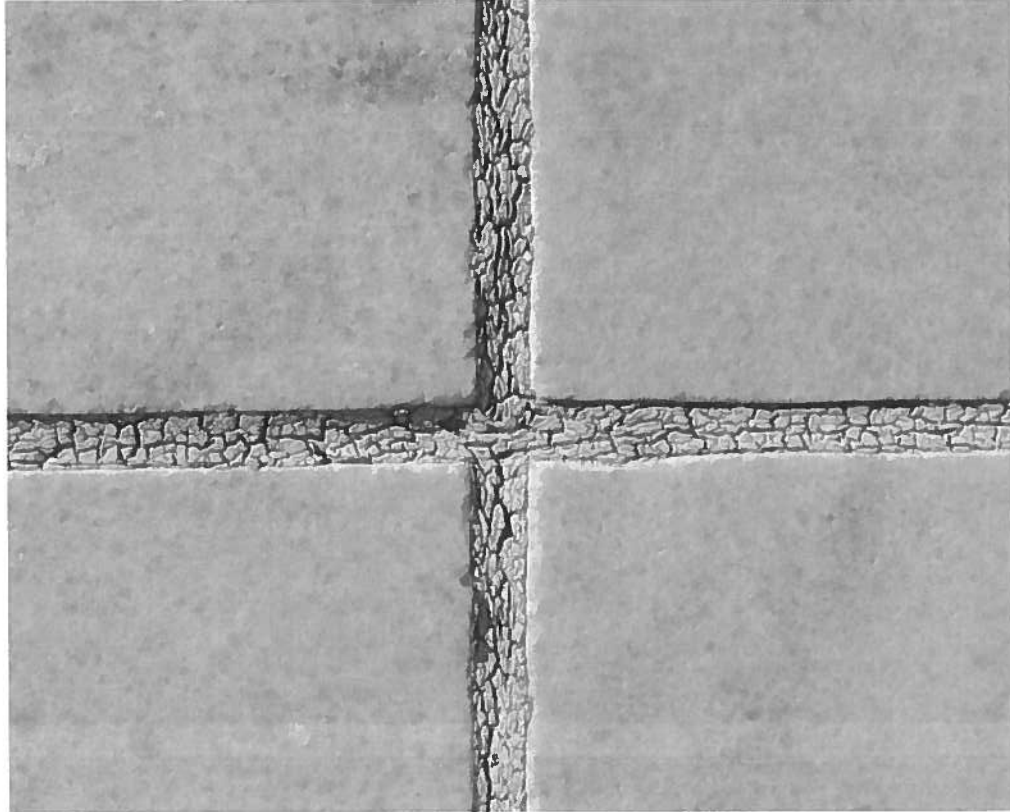
In the portion of their report related to the walls, they noted that the through-wall flashing under the parapet coping stone was severely deteriorated and cracked. Additionally, the joints between the coping stones were cracked and deteriorated and need to be tuck pointed.

The report also noted that all of the existing urethane sealant joints within the marble areas on the north and south elevations need to be cut out, cleaned, primed, backed and sealed using a one-part urethane sealant. They also noted that the same process of repair is required for all sealants around the windows on the north façade.

Cracked joints between marble panels

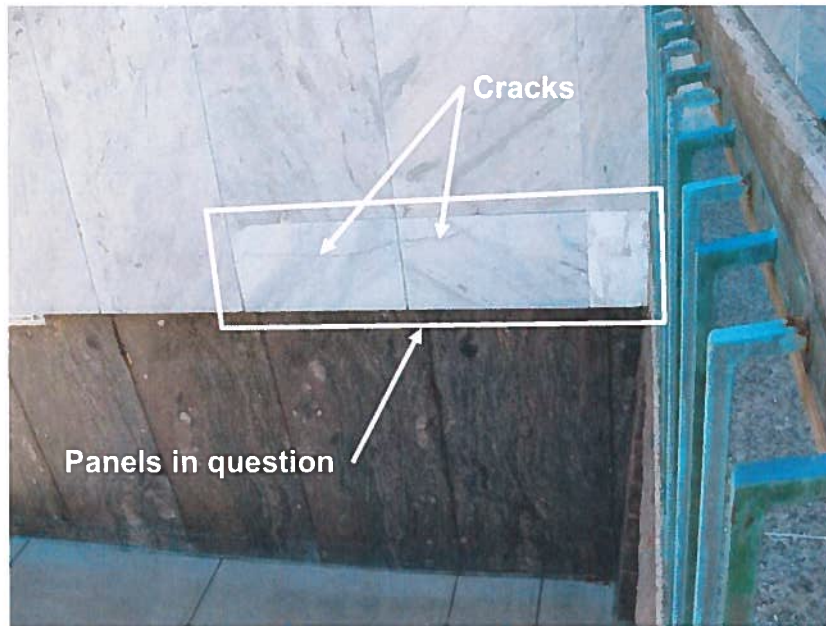
In particular, the following notes indicate that repairs were planned and presumably completed in areas that are presently failing again. Drawing sheet 1 of 5 called for "new ½" expansion joints in top course of stone" of the south façade. Sheet 3 of 5 indicated that "3 stone panels" at the plaza level of the north façade were to be removed, repaired and reset. Two of those panels have cracked again and none of the three match the original panels in color; it is probable that these were replaced after being removed rather than repaired and reset.

Cracked replacement panels

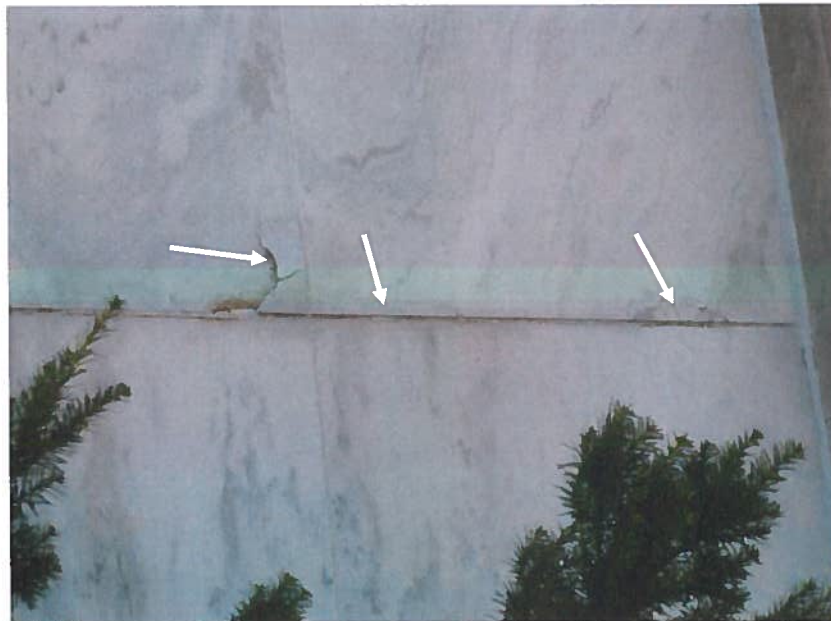
The north façade faces MacArthur Square Park, which is also bounded by the police headquarters, the county courthouse and the county jail. The north façade shows evidence of prior repair and replacement of some marble panels as well as continued cracking of the marble. The replaced panels were not an exact match and the color difference can easily be seen. These replaced panels have also cracked, emphasizing that the underlying problem of directing the moisture has not been resolved. Additionally, joints around the window system are deteriorating as well.

Cracking of marble panels on north facade

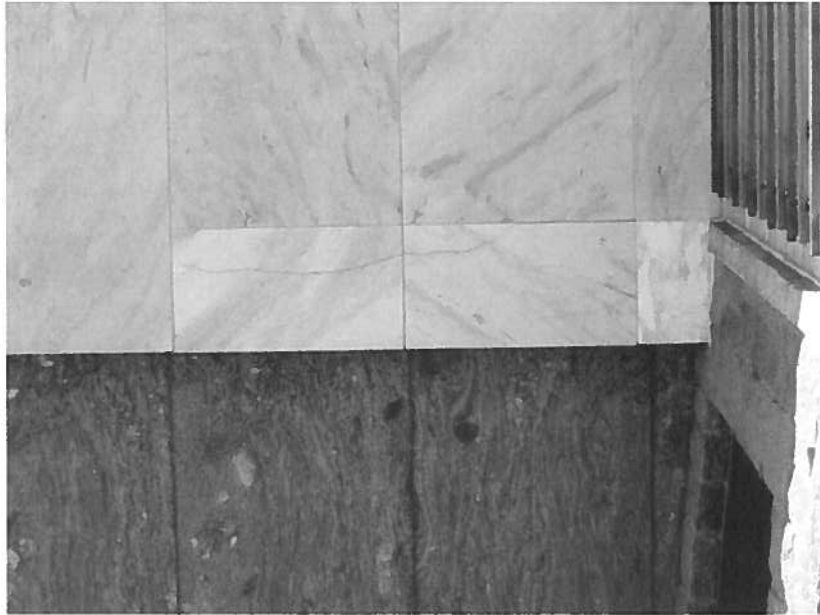
Replaced panels with new cracks

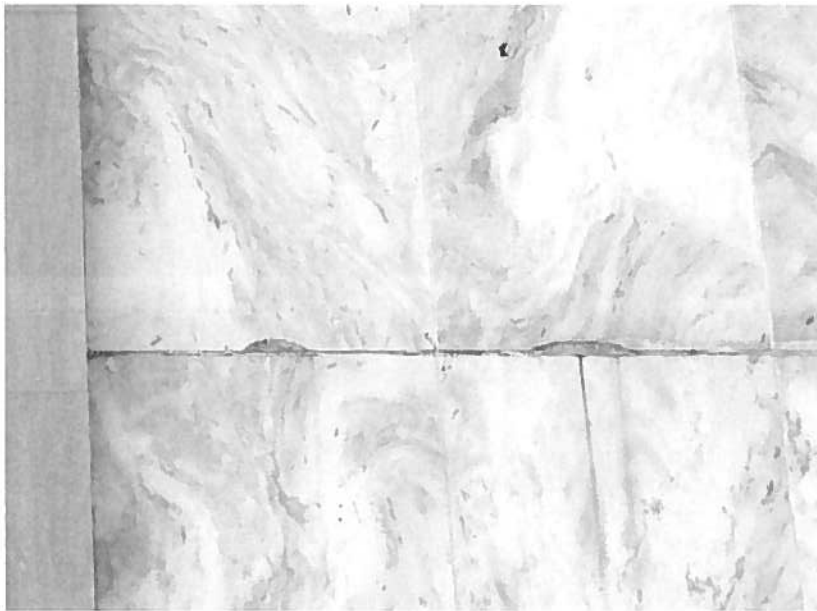
Cracked marble at joints

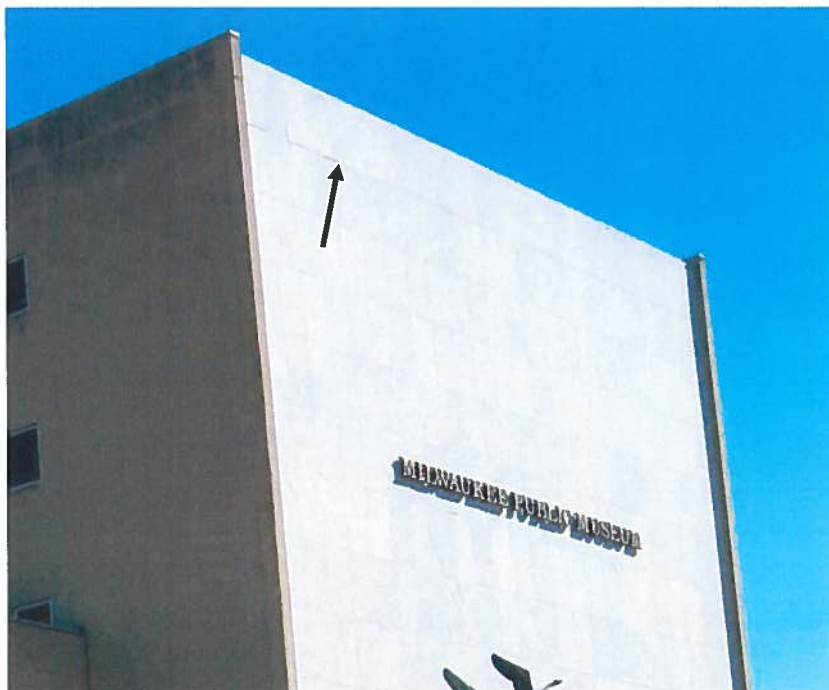
As seen in the photo below, there is some movement and deterioration of the joints just below the top course of panels, which were repaired in 1977.

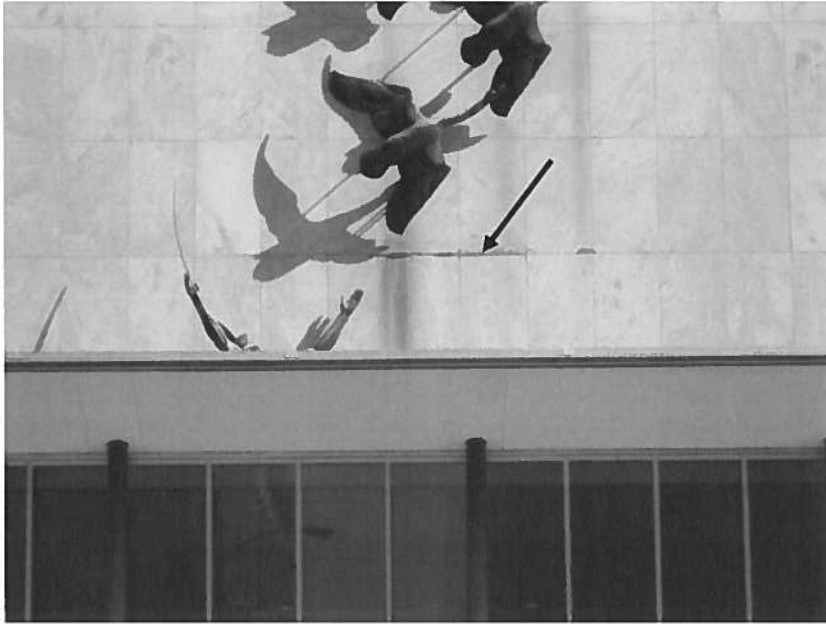
The joints between rows of panels show evidence of failure of the support system with joints cracked and panels pulling away from the building. Many of these cracks have been patched in the past and are failing again.

Previously patched and failing joints just above the main entry

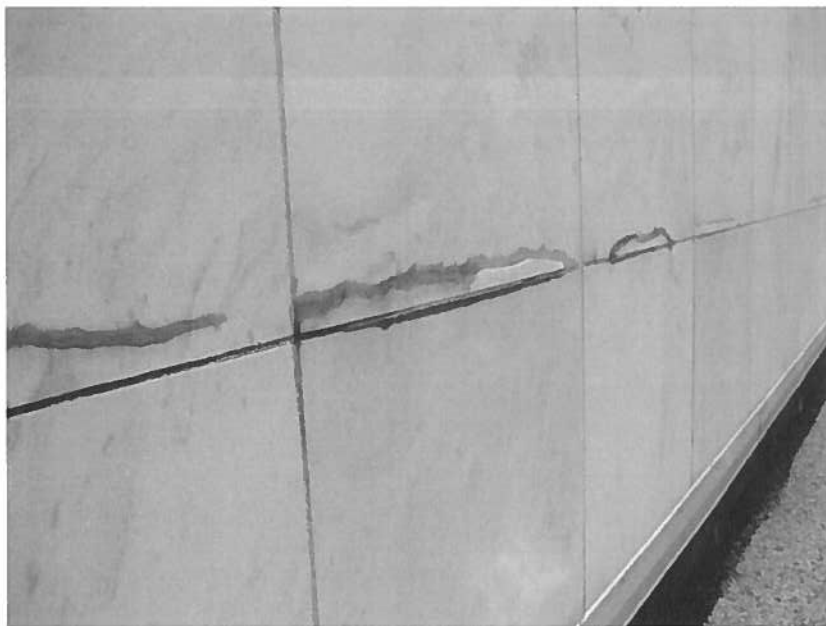
Close-up view of failing joints and cracked marble

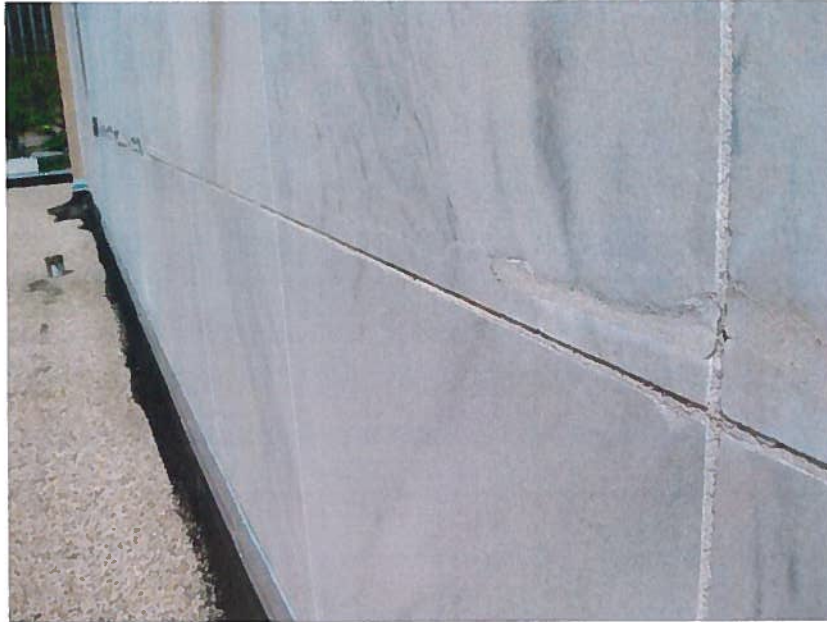
Cracked and failing joints and previous repairs

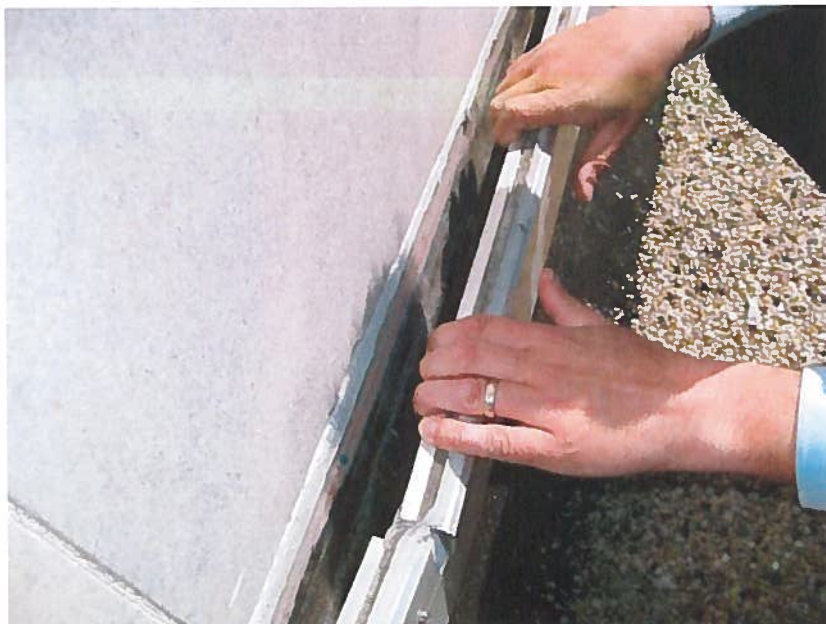
The deterioration of the joints may also begin to impact the roofing of the main entry; the joint above the metal flashing has failed and allowed the base flashing to pull away from the wall. This allows moisture to work its way into the wall and under the roofing, eventually leaking onto the ceiling of the lobby area.

Deterioration of joint at base flashing to lower roof

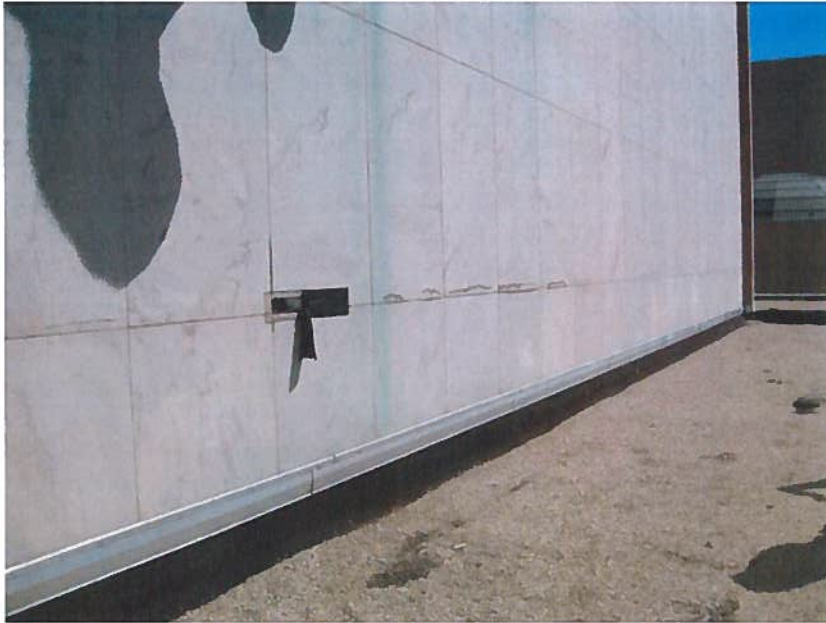
Currently, the marble panels are attached to the concrete masonry unit backup wall with steel shelf angles located at every third row of panels. The shop drawings indicated that these are continuous steel angles with continuous bars; there is no flashing indicated on the drawings. The only opportunity for drainage if moisture gets into the wall is behind the angle in areas where the angle is shimmed out. One area of the south façade wall that included an angle was opened up and is shown below. In keeping with the shop drawings, no flashing was observed.

Exploratory patch on south façade at shelf angle

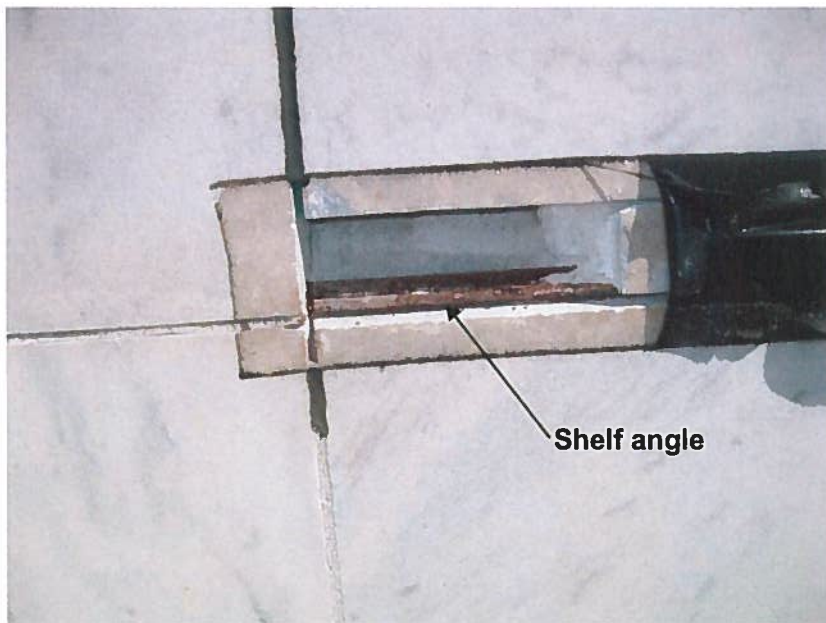
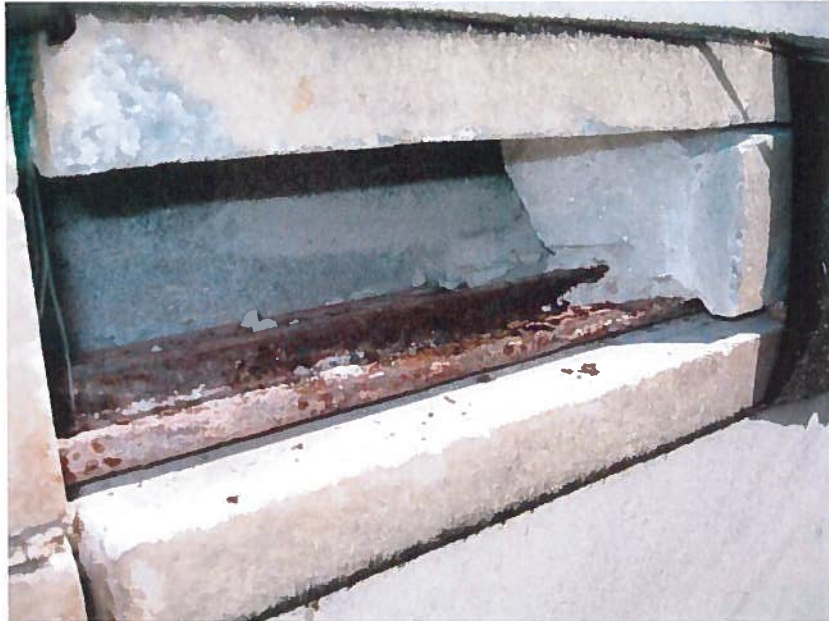
Deteriorating shelf angle

Once the marble veneer panels are removed, an assessment can be made of the extent of deterioration of the shelf angles. It is possible that the angles could be cleaned, repainted and reused. If the shelf angles cannot be salvaged, they should be replaced with new galvanized angles. A new flashing system should be designed, detailed and installed, and the marble reattached with new or additional ties. Some marble panels will be beyond repair and will need to be replaced. Other panels may break during removal and reinstallation. These panels would then need to be replaced with new panels which will not match. The replaced panels will always be obvious and will always stand out from the original panels.

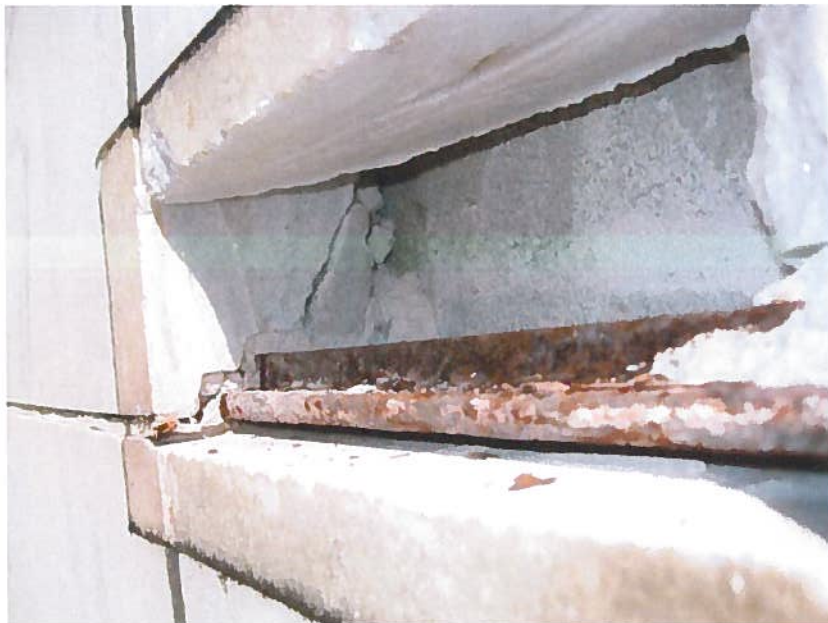
Shelf angle with no flashing
